# SYRIAN ARAB REPUBLIC

## IDLIB CITY

IMAGERY ANALYSIS: 09/02/2023 PUBLISHED 11/02/2023 V1.

### Damage Assessment in Idlib Syria as of 9 February 2023

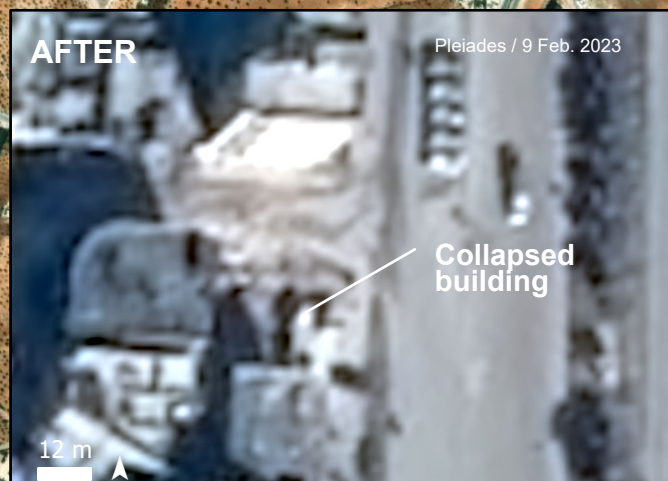
This map illustrates potentially damaged structures/buildings by the 06th of February 2023 earthquake in Idlib, Syria as detected by using a Pleiades very high-resolution satellite image acquired on 9 February 2023. Within Idlib, UNOSAT identified 79 damaged/potentially damaged structures.

Important note: Damage caused by the earthquake may be underestimated due to the existence of damaged structures before the 06th of February 2023 Marash/Antep earthquake.
